RTB1009

PRECISION THROTTLE CONTROL FOR PRECISION ACCELERATION

ABOUT ELECTRONIC THROTTLE BODIES

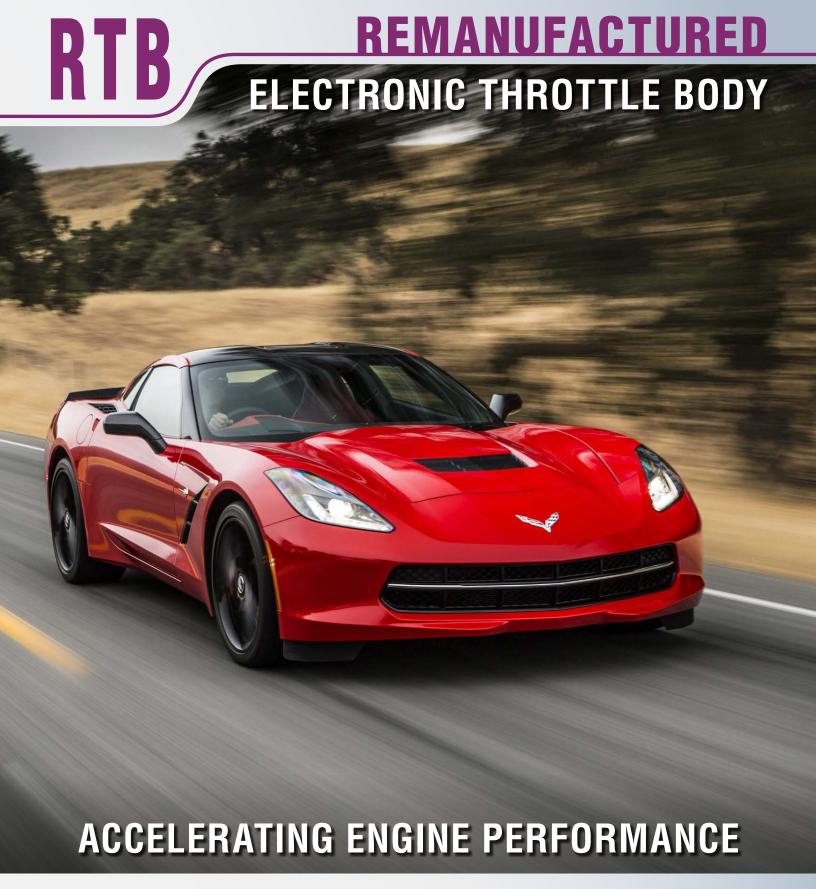
Acceleration in modern cars requires precision. Throttle control had to evolve and the **ETB** (Electronic Throttle Body) is the answer to that. By replacing the mechanical link between pedal and throttle with digital sensors, the **ETB** gives the **ECM** (Engine Control Module) greater control based on redundant signals from the accelerator pedal. The throttle valve is now fully automated, controlled only by a small motor within the throttle body.
